**Passaic Valley Sewerage Commissioners  
Response to Request for Information  
USEPA, Region 2**

**Service Area Drainage and  
Land Use Report  
for the Towns of  
Harrison and Kearny,  
The Borough of East Newark, and the  
Cities of Newark and Paterson**

**Combined Sewer Overflow**

**The Towns of Harrison and Kearny and  
The Borough of East Newark**

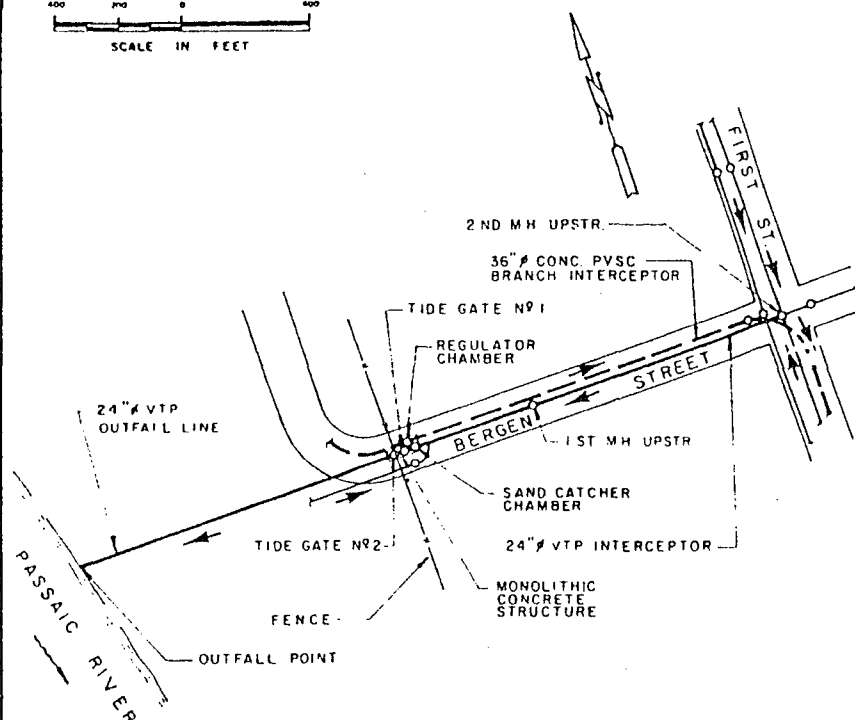
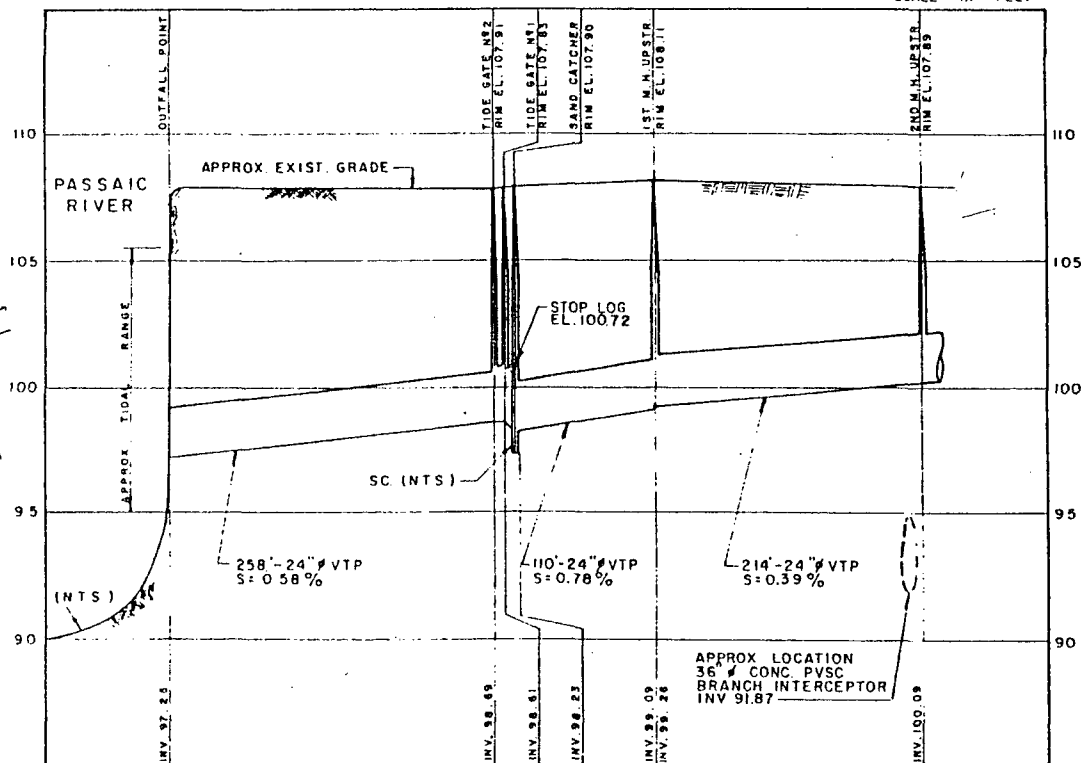
PASSAIC VALLEY SEWERAGE COMMISSIONERS  
OVERFLOW CHAMBER H-006  
BERGEN STREET, HARRISON  
PLAN AND PROFILE  
ELSON T. KILAM ASSOCIATES, INC.  
*Environmental and Hydraulic Engineers* 40 THREE STREET MILLBURN NEW JERSEY 07041

Tide gate No. 1 leaking. Tide gate  
No. 2 broken off and jammed in chamber

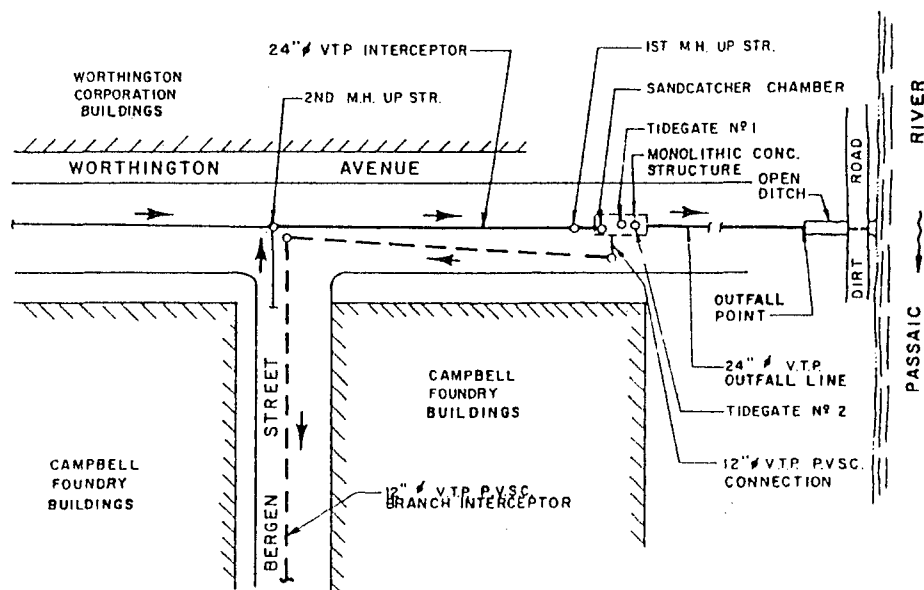
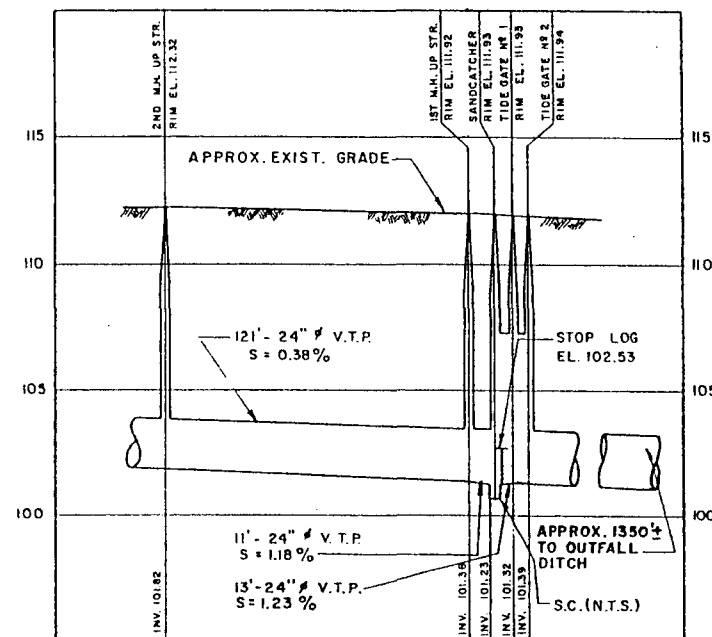
PASSAIC VALLEY SEWERAGE COMMISSIONERS  
OVERFLOW CHAMBER H-007  
WORTHINGTON AVENUE, HARRISON  
PLAN AND PROFILE  
ELSON T. HILLAM ASSOCIATES, INC.  
Environmental and Hydraulic Engineers 4000 STREET WILLIAM NEW YORK, N.Y. 10001

No measurable overflows were recorded at this chamber because of the fact that the outfall line, which extends some 1,350 feet into the Meadowlands, is clogged with debris. Due to the obstructed outfall line, the overflow chamber becomes surcharged during periods of storm flow, thereby negating metering attempts, since no "free board" overflow condition existed. In other words, with the occurrences of high storm flows, the stormwater is carried on downstream.

both tide gates noted as leaking

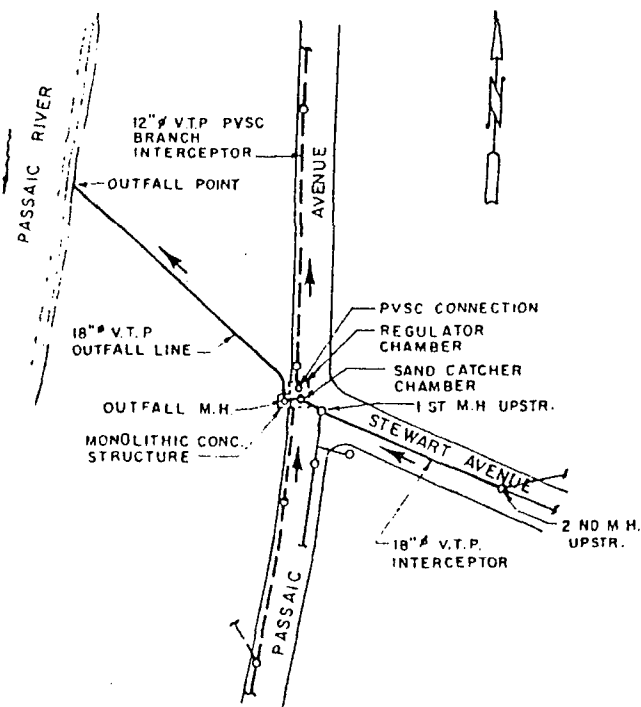
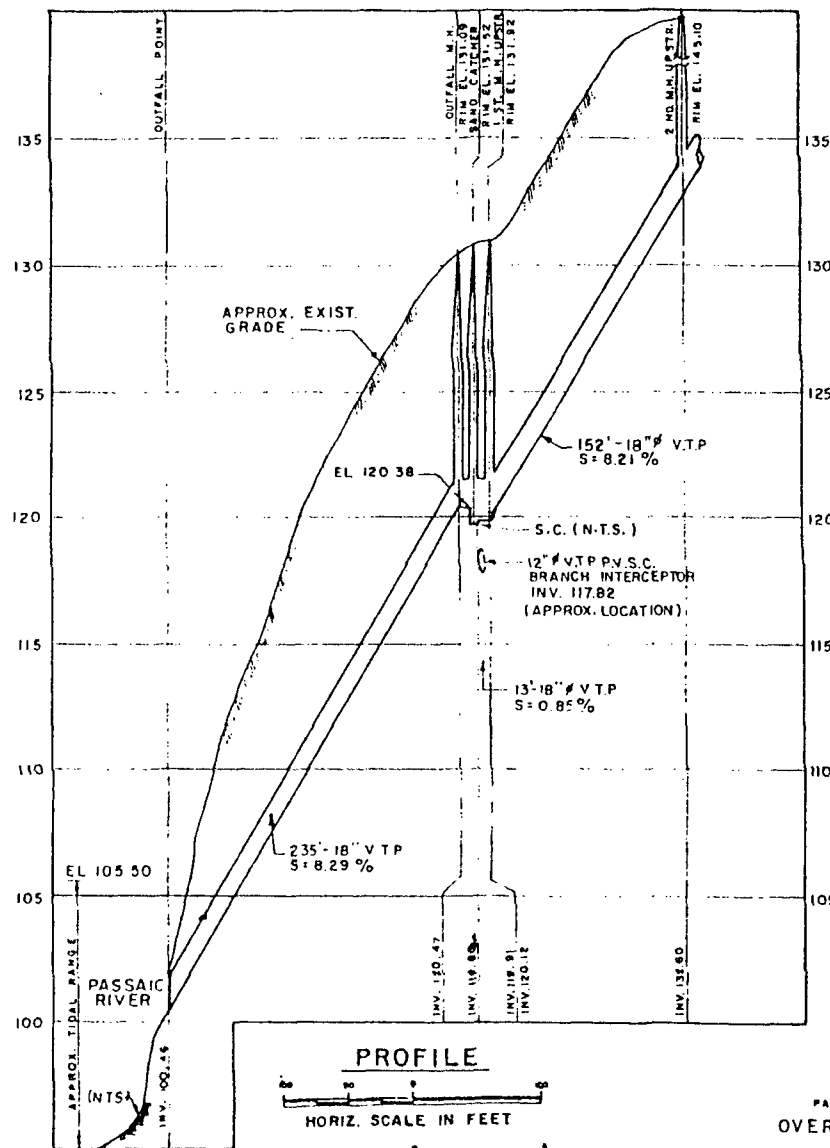
Condition of Regulator: appears inoperable

Overflow Stop Log/Dam  
Condition: no stop logs present; overflow must  
reach invert of outfall line

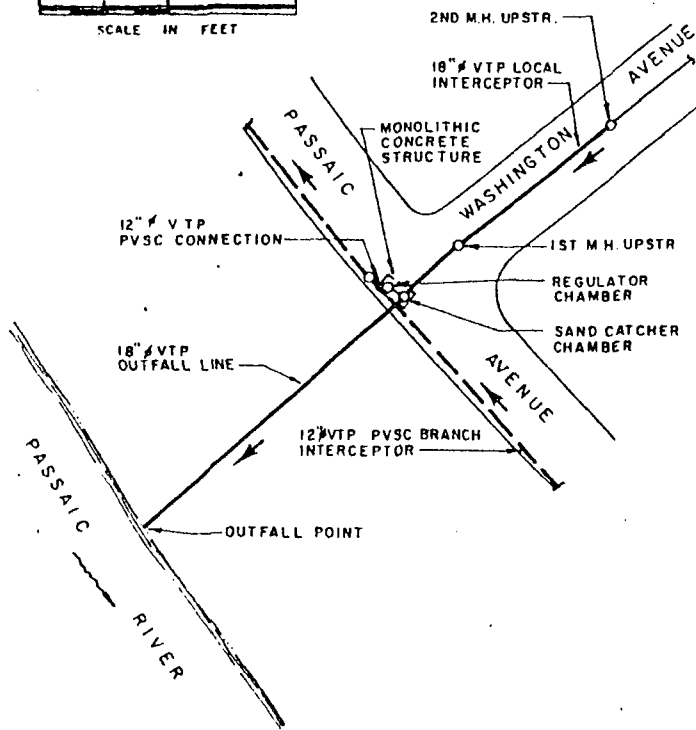
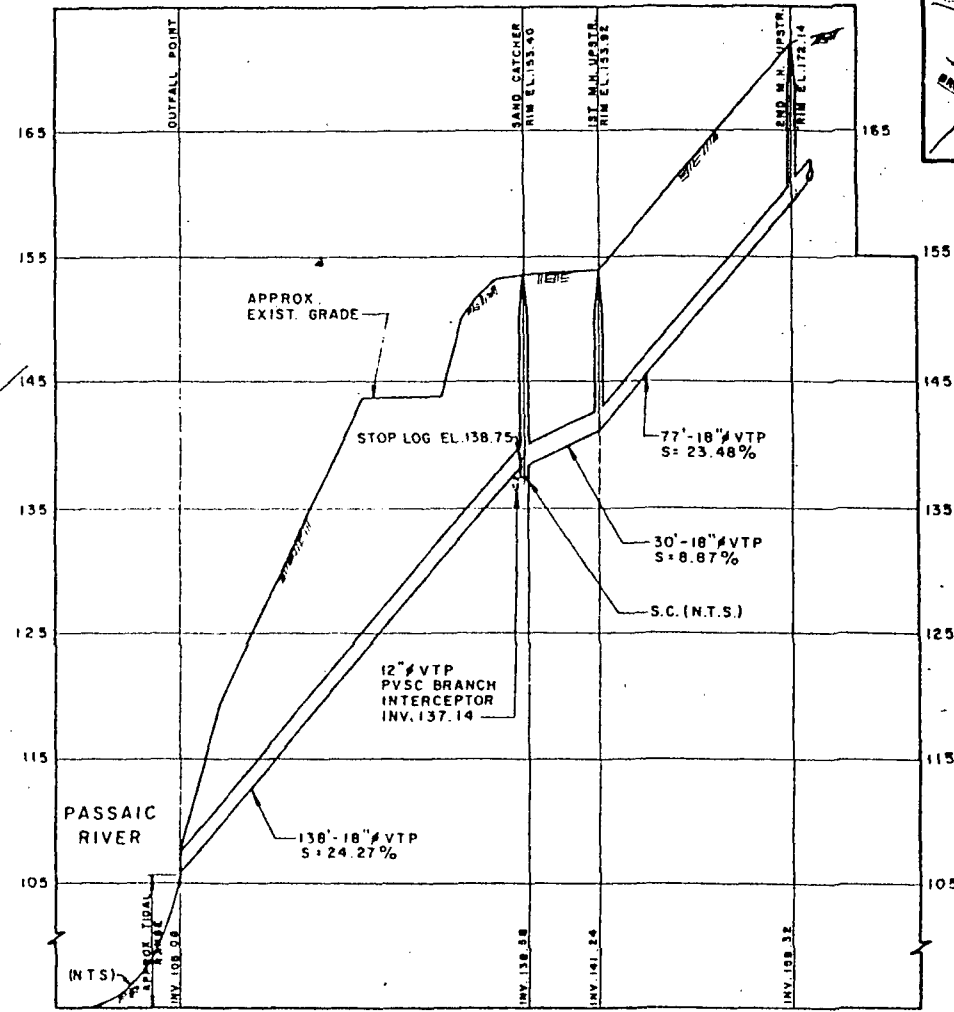
Condition of Regulator:                      Appears inoperable

Overflow Stop Log/Dam  
Condition: stop logs located at downstream  
end of sand catcher ahead of  
opening to outfall line

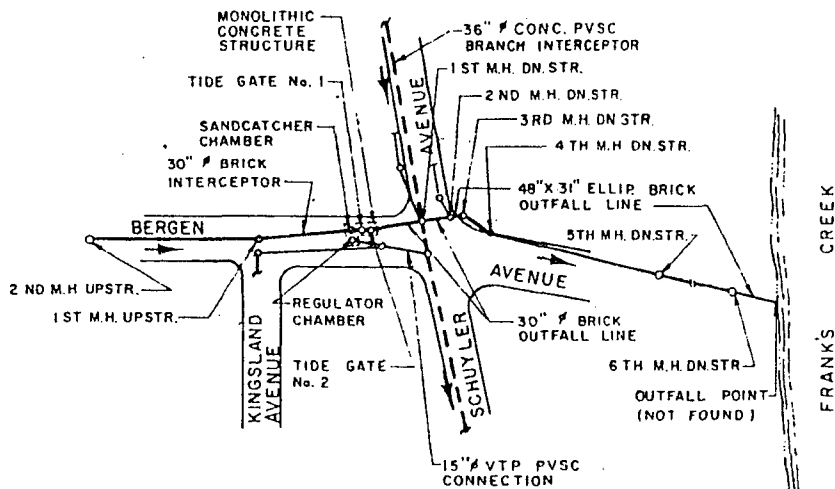
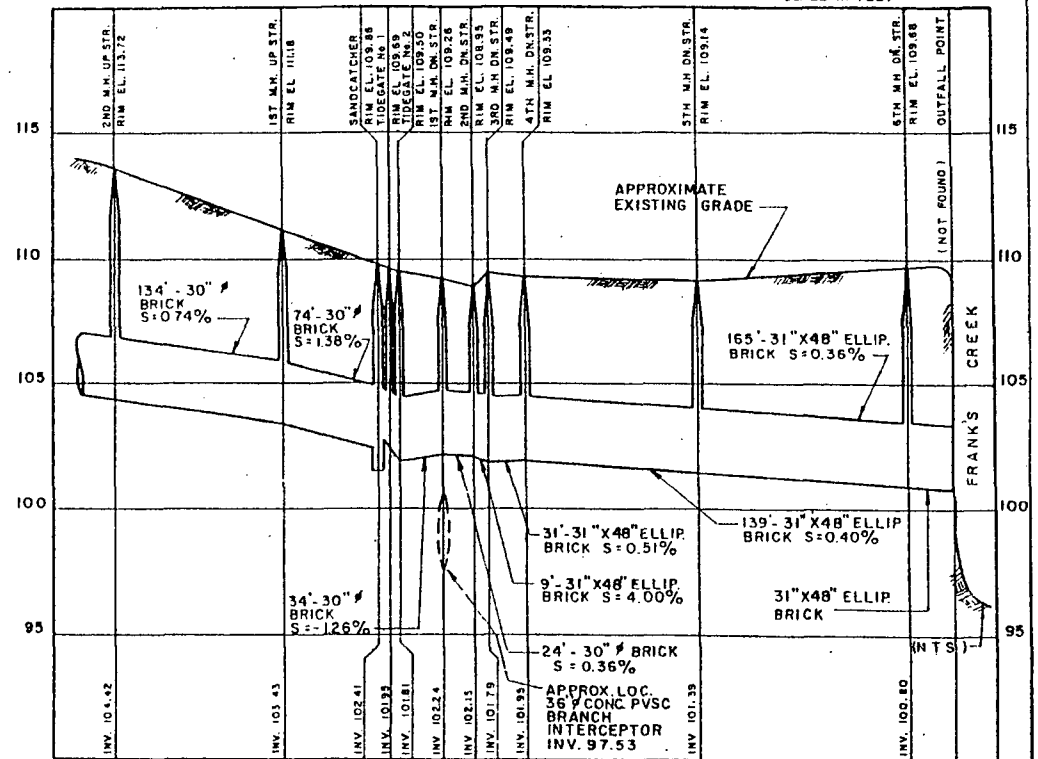
PASSAIC VALLEY SEWERAGE COMMISSIONERS  
OVERFLOW CHAMBER K-008  
BERGEN AVENUE, KEARNY  
PLAN AND PROFILE  
ELSON T. KILLAM ASSOCIATES, INC.  
Environmental and Hydraulic Engineers - 40 FRANK STREET, WALLINGFORD, NEW JERSEY 07093

Condition of Regulator:	appears inoperable
Special Actions Required:	none
Overflow Stop Log/Dam Condition:	none (no stop logs); for overflow, level must reach invert of line to tide gates
Tide Gate Condition:	both gates missing from chambers

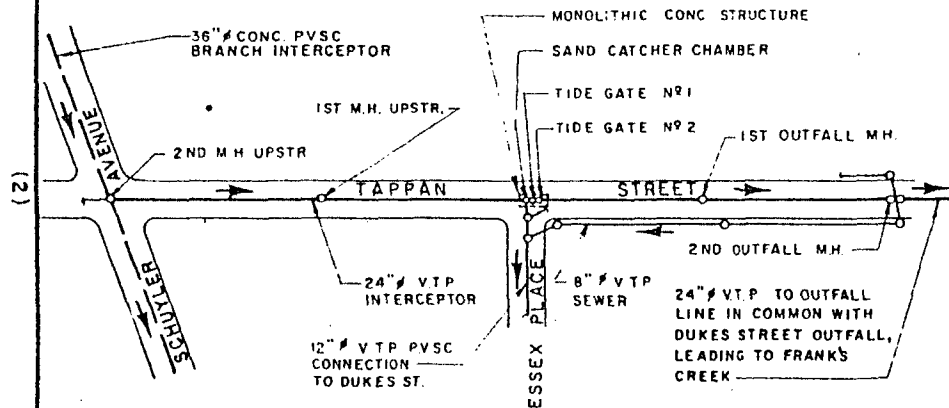
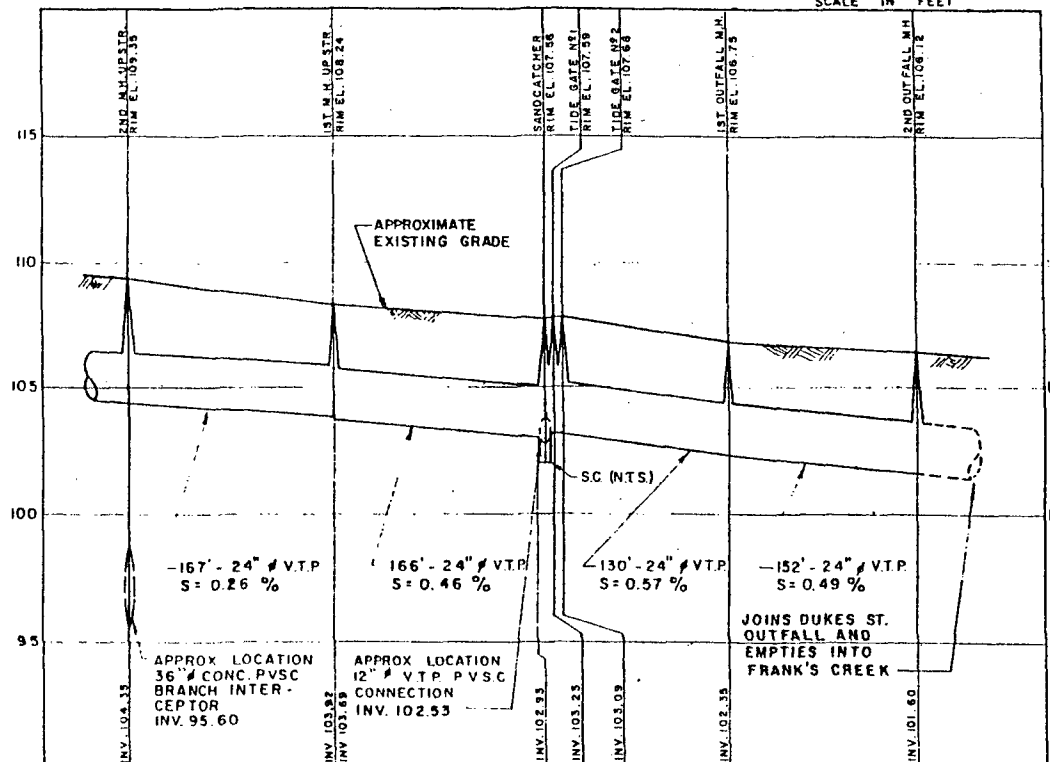
PASSAIC VALLEY SEWERAGE COMMISSIONERS  
OVERFLOW CHAMBER K-009  
TAPPAN STREET, KEARNY  
PLAN AND PROFILE  
ELSON T. RILLAM ASSOCIATES, INC.  
Environmental and Hydraulic Engineers 4000 STREET 111, NEW JERSEY 07001

Condition of Regulator:	appears inoperable
Special Actions Required:	none
Overflow Stop Log/Dam Condition:	no stop logs or stop planks present
Tide Gate Condition:	both tide gates missing from chambers

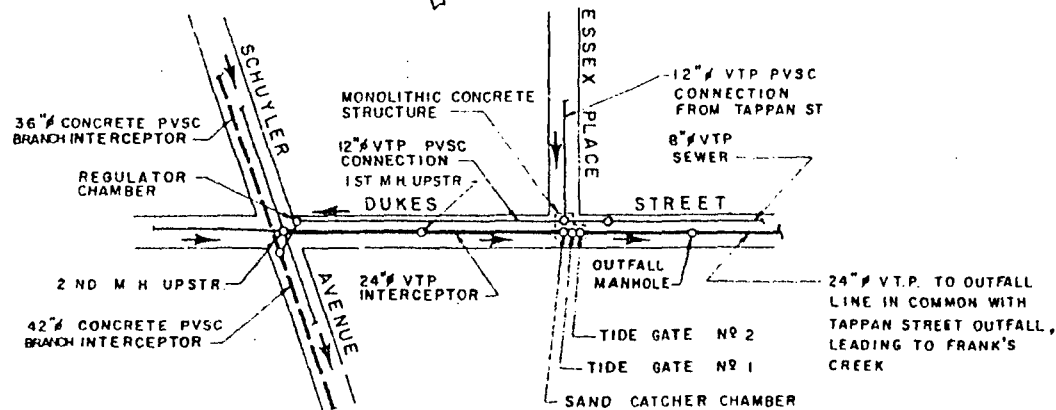
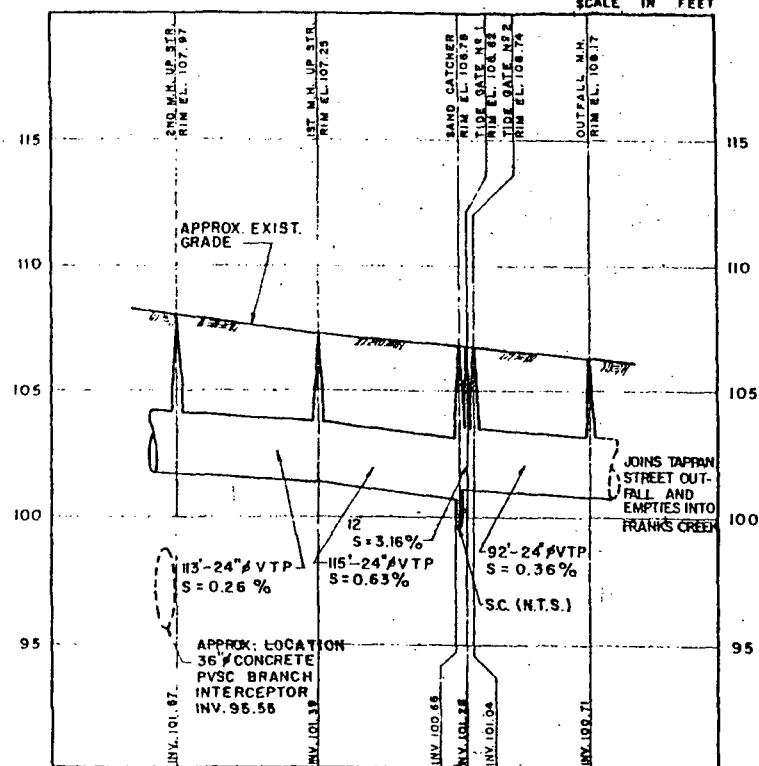
Condition of Regulator: appears inoperable (located at  
Dukes St. and Schuyler Ave.)

Overflow Stop Log/Dam Condition: none (no stop logs exist)

Tide Gate Condition: both tide gates missing

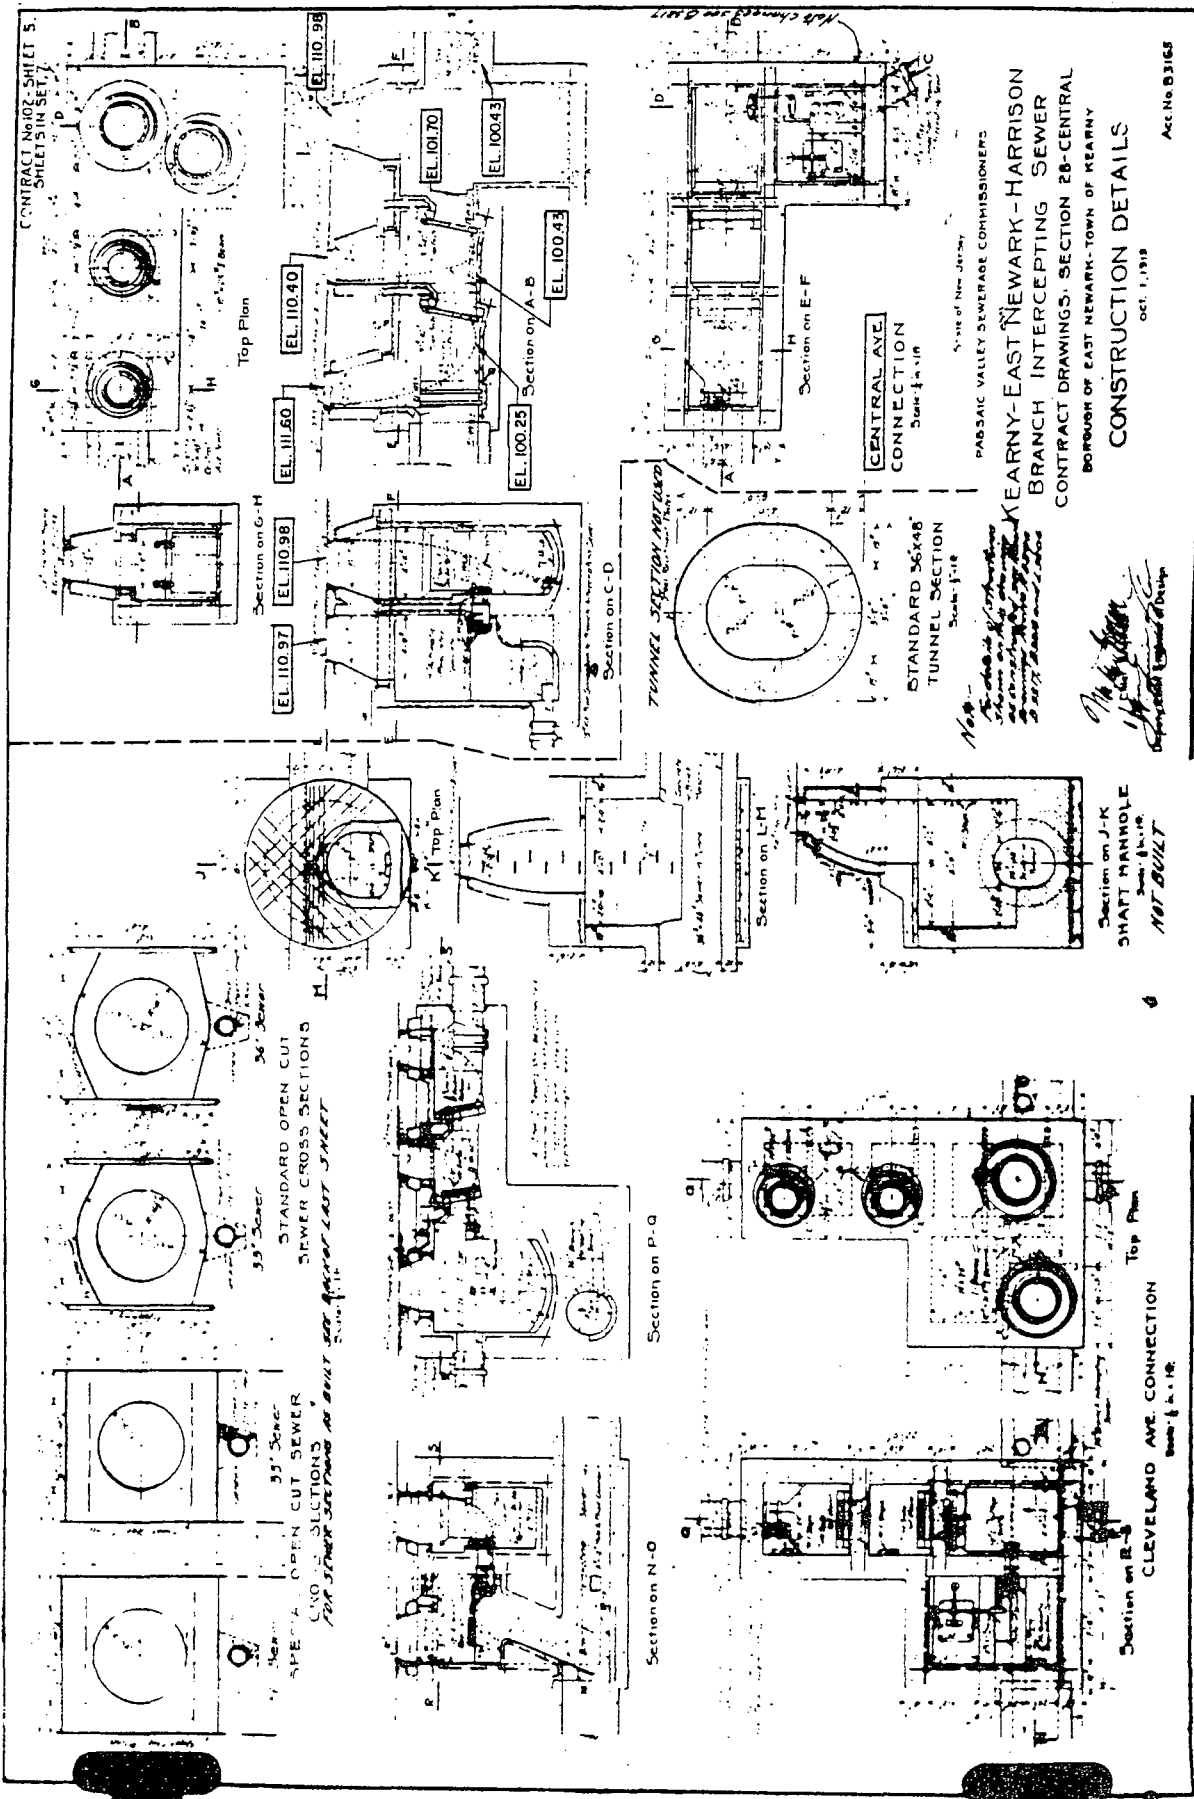
PLATE B

15"  $\phi$  FLAP  
VALVE  
(FLAP  
MISSING)

Condition of Regulator:	appears inoperable
Special Actions Required:	none
Overflow Stop Log/Dam Condition:	located at downstream end of sand catcher, just before portal to first tide gate chamber
Tide Gate Condition:	both tide gates leaking
